**ENERGY SURVEY OF  
EISENHOWER ARMY MEDICAL CENTER  
FORT GORDON**

**AUGUSTA, GEORGIA**

**NARRATIVE REPORT**

**DECEMBER 23, 1996**

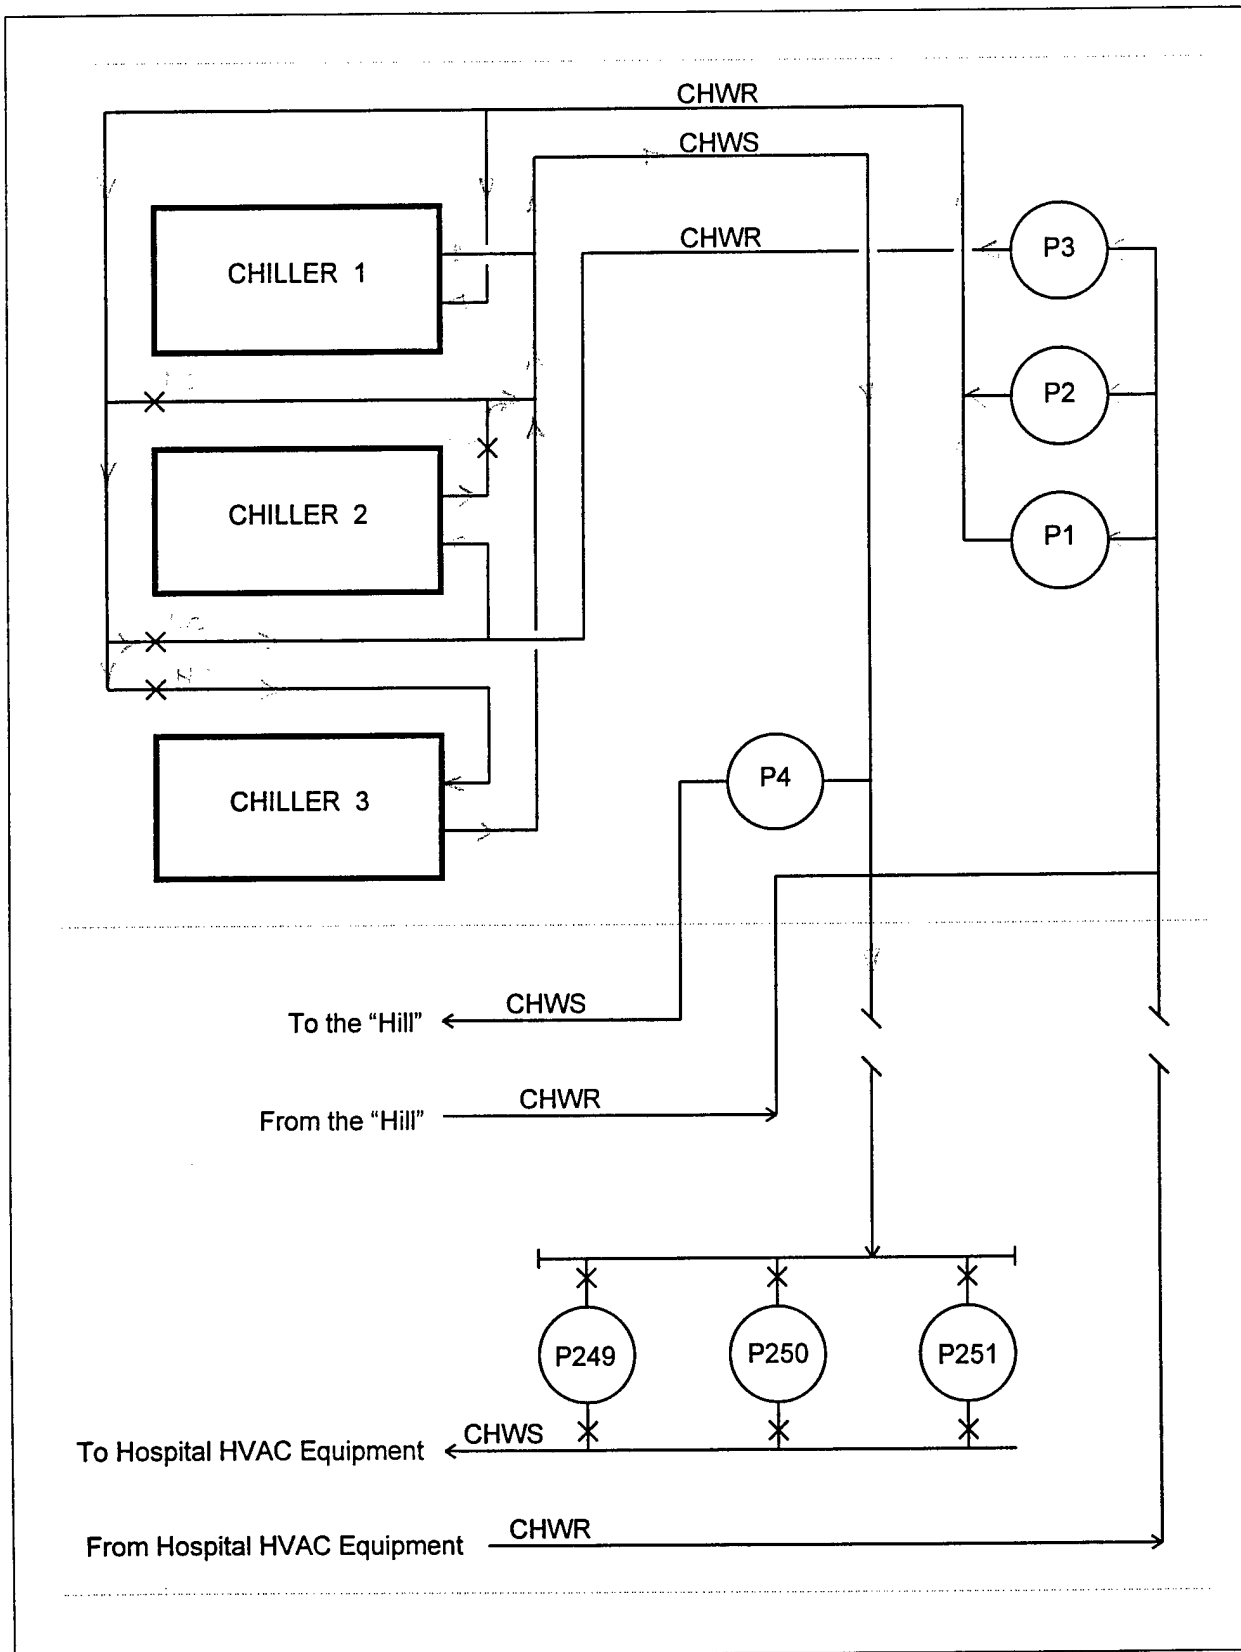
Figure 2.2-2

Chiller CH-2 is a 500 ton, natural gas-fired absorption unit manufactured by Trane. The design COP is 1.07. This chiller was installed in early 1995. The field investigation of the absorption chiller was accomplished during a cool afternoon on November 16, 1995, while the outside air temperature was 58 degrees F. Chiller CH-2 was operating at approximately 60 percent of full load fuel input and was the only chiller operating during the survey. The measured CHW supply and return temperatures were 52 degrees F and 60 degrees F, respectively. The calculated chilled water flow was 1,987 gallons per minute (gpm), compared to the design value of 1,152 gpm. The calculated condenser water flow was 2,212 gpm, compared to the design value of 2,187 gpm. The condenser water flow is normal, but the chilled water flow exceeds the recommended maximum of 1,466 gpm. This could cause premature fouling in the evaporator tubes.

The loading of the absorption chiller was dictated by the leaving condenser water temperature and not the actual cooling load required by the hospital. The fuel input was manually adjusted to keep the leaving condenser water temperature at approximately 100 degrees F. Chiller CH-2 has not been operated very often due to excessive condenser water temperatures. This problem is discussed in detail in the paragraphs below on cooling towers.

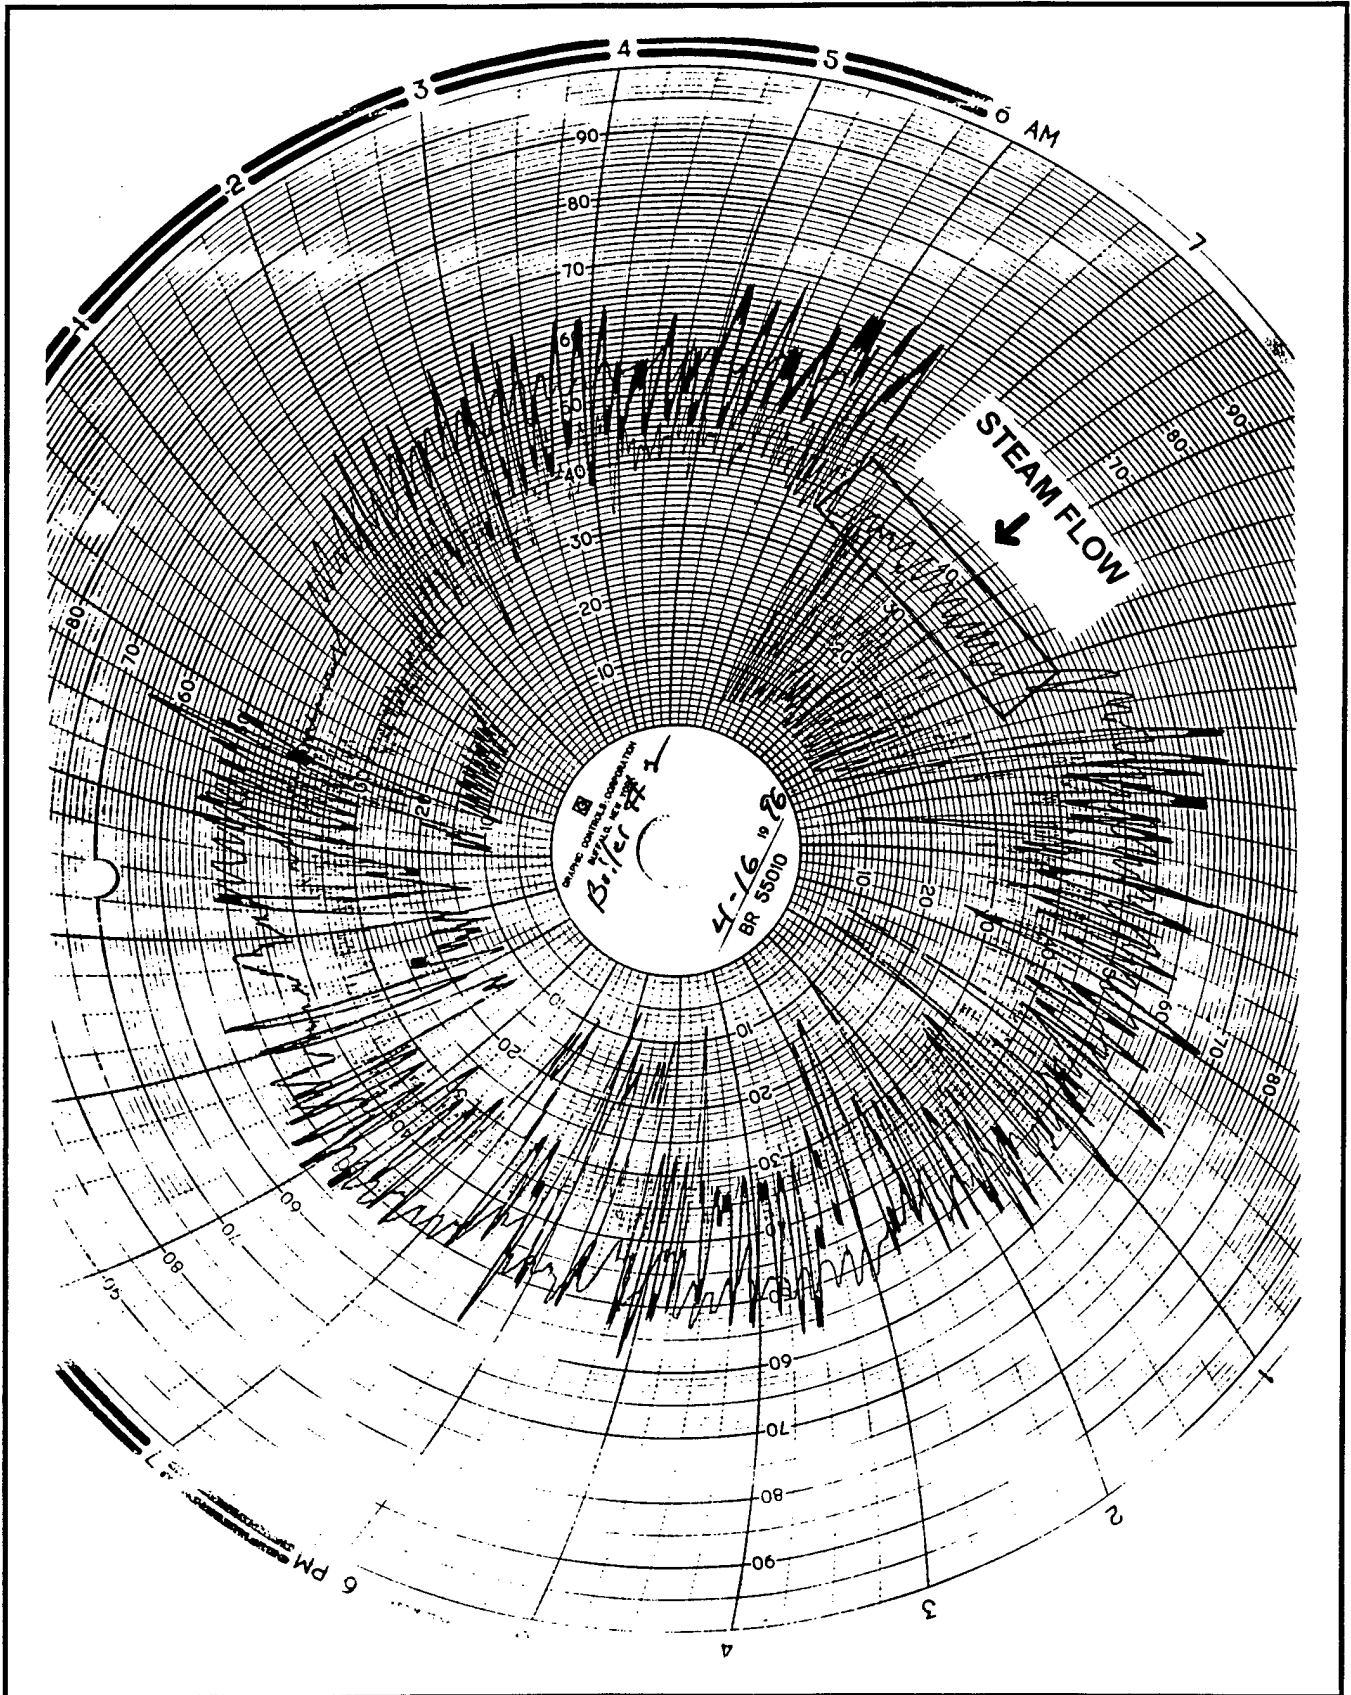
Figure 4.3-5

Typical Steam Flow Noted Before 4-18-96

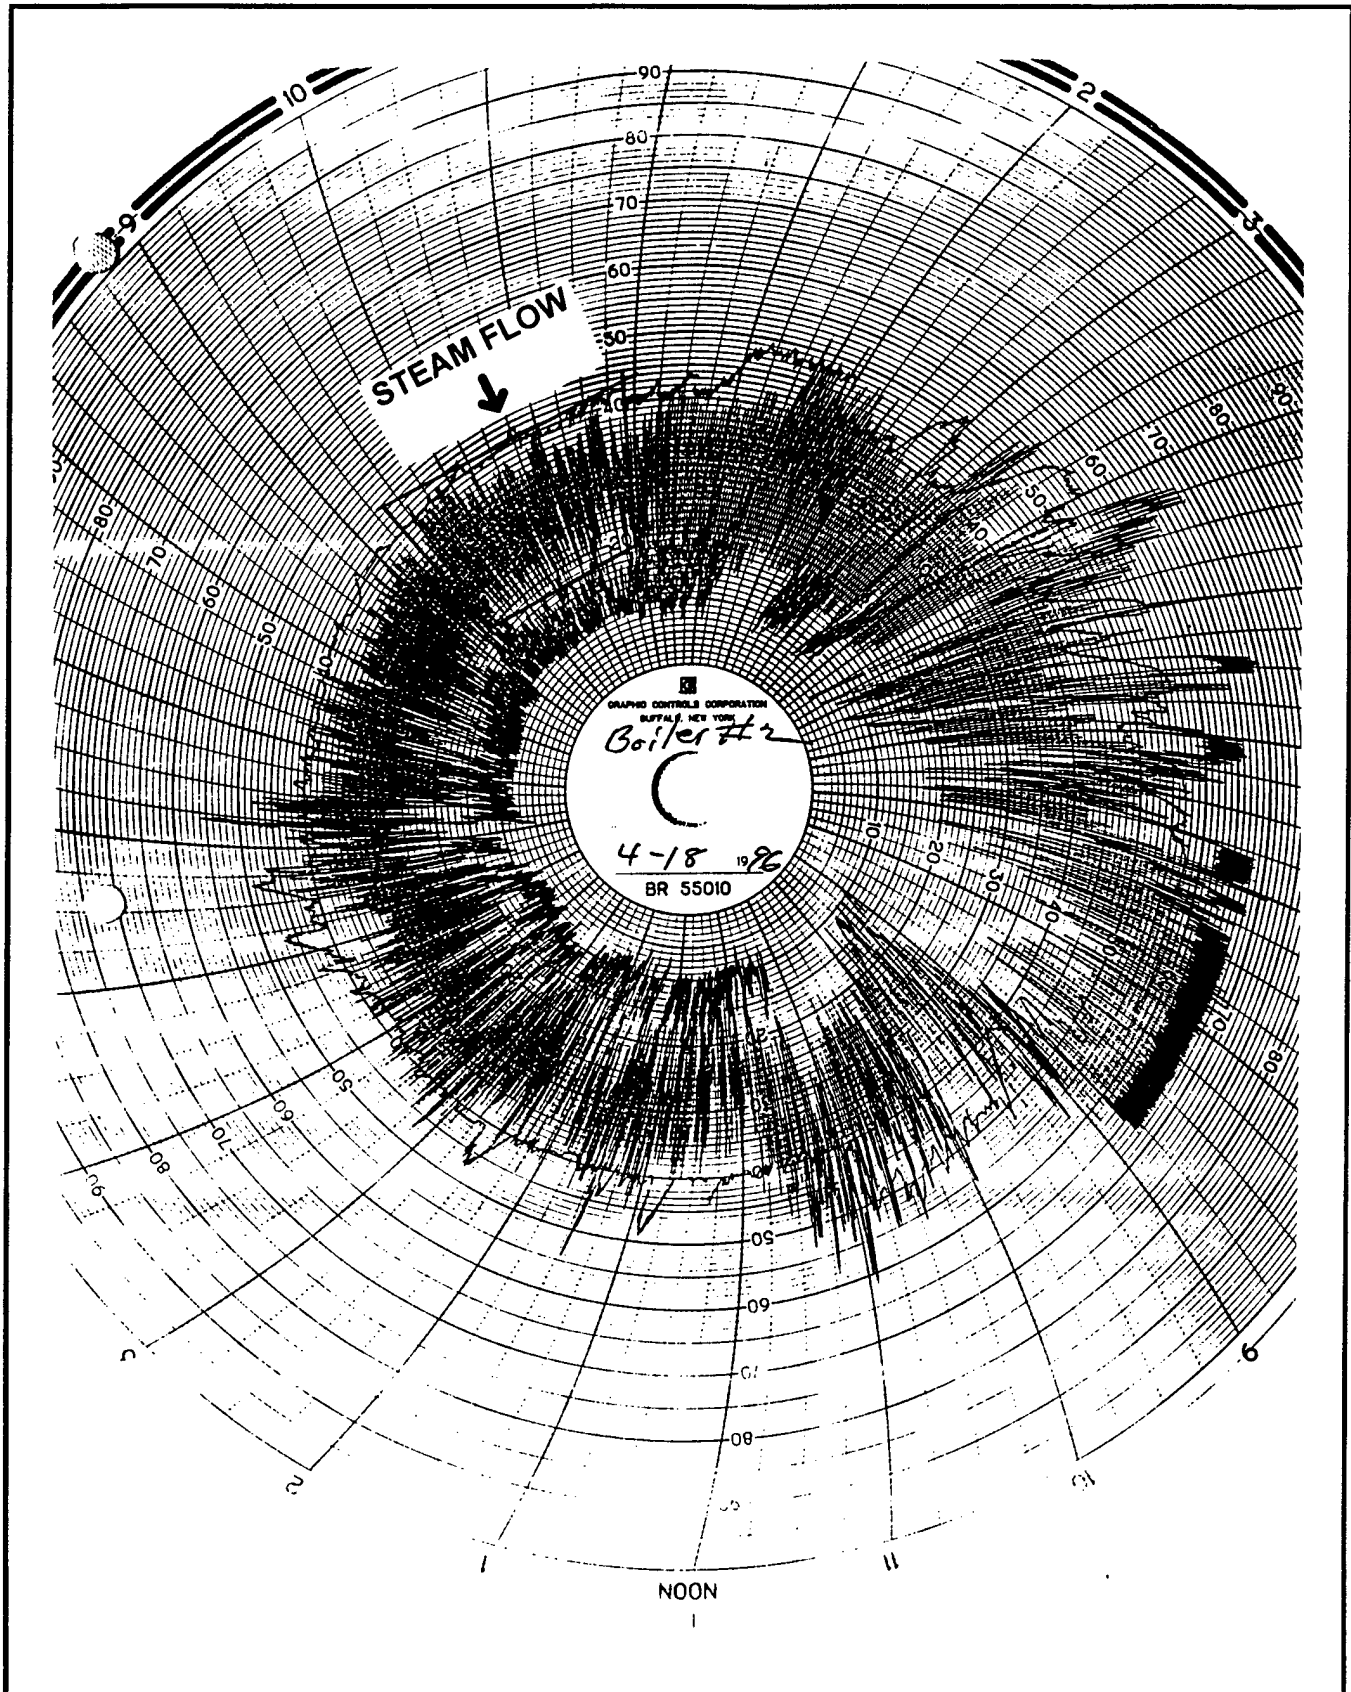
Figure 4.3-6

Steam Flow Observed 4-18-96 to 8-13-96

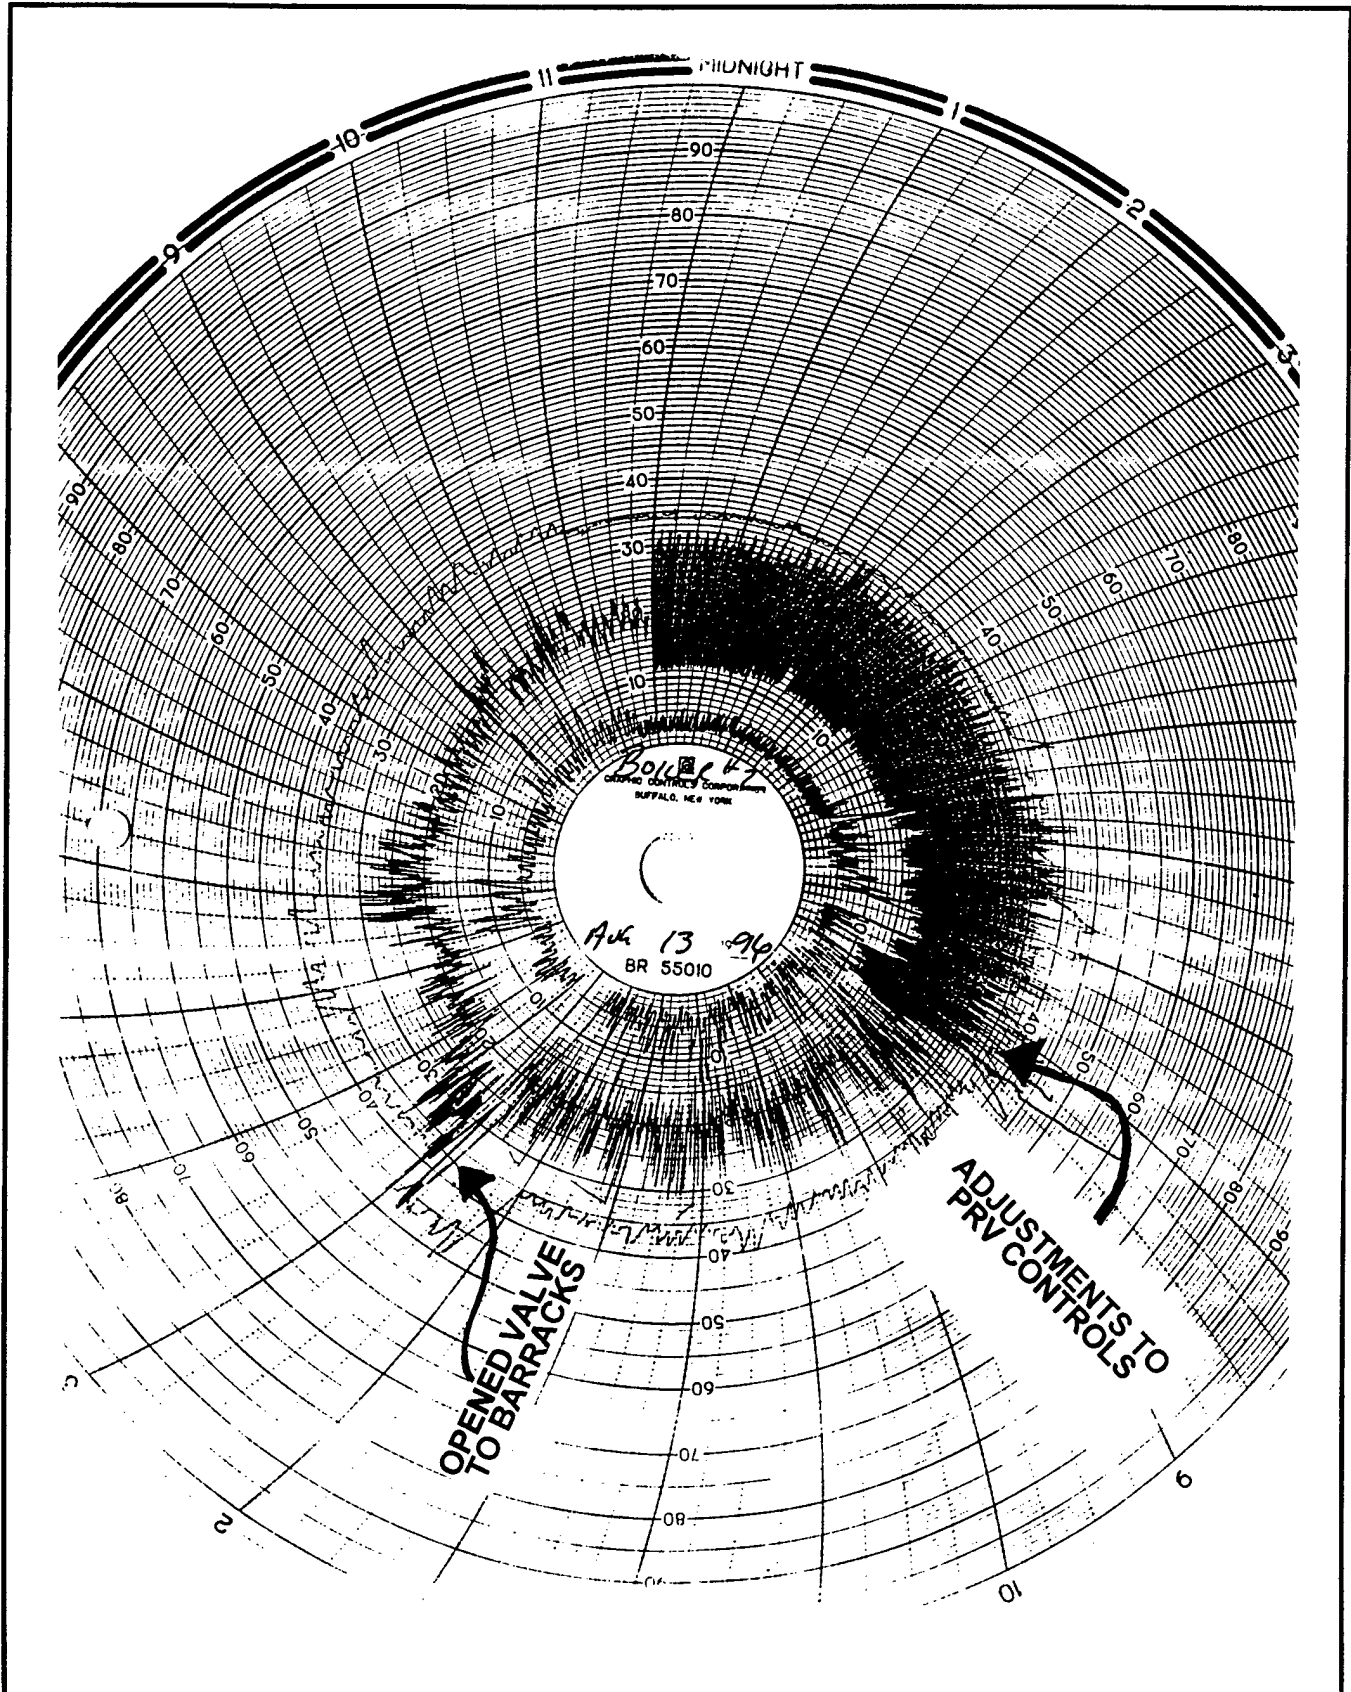
Figure 4.3-7

# Steam Flow During PRV Controls Adjustments
